## **TURNING PERFORMANCE OF DIAMOND-COATED INSERT**

R. J. Talib, H. M. Ariff

*AMREC, SIRIM Bhd. Lot 34, Jalan Hi-Tech 2/3, Kulim Hi-Tech Park, 09000 KULIM,  
Malaysia*

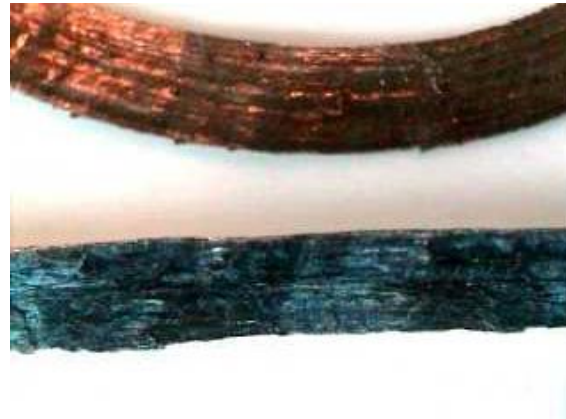
Figure 2: Change of chip colour from brown to dark blue

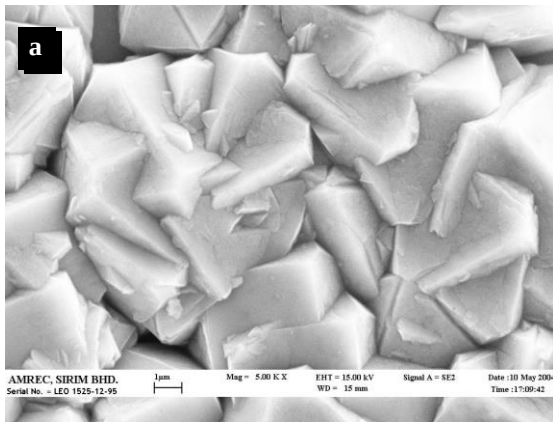
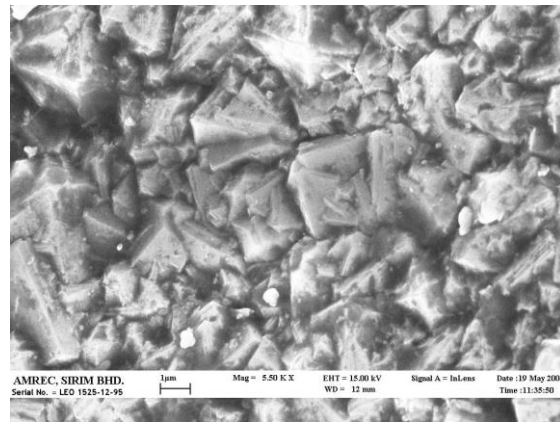
Heat is generated during turning process due the friction between the insert and the work piece. This phenomenon resulted in diffusion of carbon contents from the diamond coating into the work piece materials and formed metal carbides (MC) on the work piece. The formation of metal carbide on the work piece which is quite hard depending on the metal element may damage the diamond coating as shown in Figure 3.

Figure 3: SEM image of diamond coating; (a) before turning test, (b) after turning test

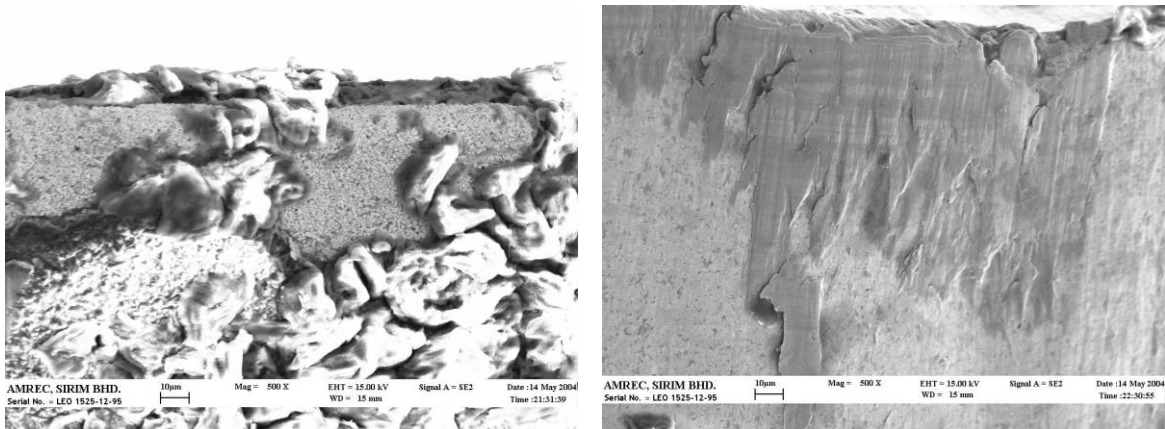
As the turning process progressed, the adhesion of diamond coating with the substrate will be weakened and finally diamond coating was disposed from the substrate material. Subsequently exposing the substrate material and forming build-up edge (Figure 4a and Figure 4b).

Figure 4: SEM images of diamond-coated surface, (a) damaged surface, (b) BUE

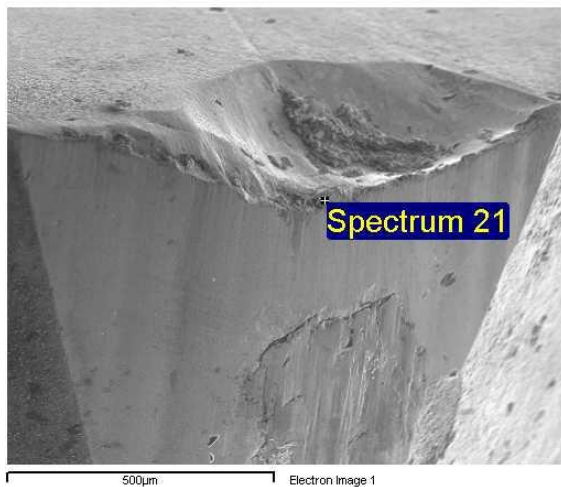
In the early stage of machining, the transfer of material from the work piece to the diamond-coated insert was observed as shown in EDAX analysis. Table 1 and Figure 5 show the elements composed in the work piece material such as magnesium, aluminium, silica, and iron have been transferred on to the flank edge of the diamond-coated insert. Figure 6 shows the EDAX analysis location on the flank and it was found that the element of iron has penetrated into the flank. As the machining progressed, it was observed that only element of high melting point such iron, silica, and cobalt left on the flank. Whereas, the other elements in the composition, which have lower melting temperature such as magnesium and aluminium have evaporated to the atmosphere.

Figure 5: EDAX analysis on the flank edge

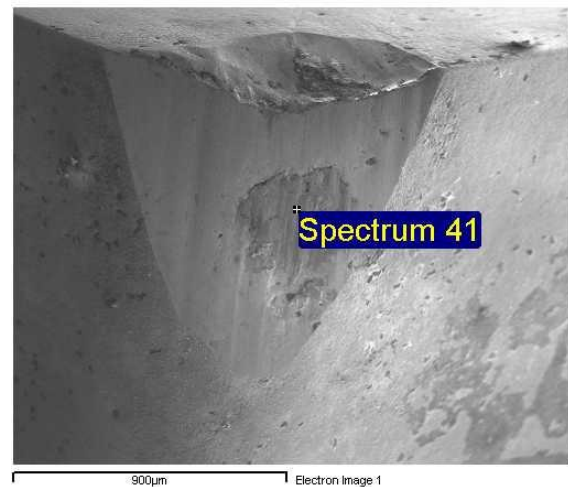
Figure 6 EDAX analysis on the flank edge

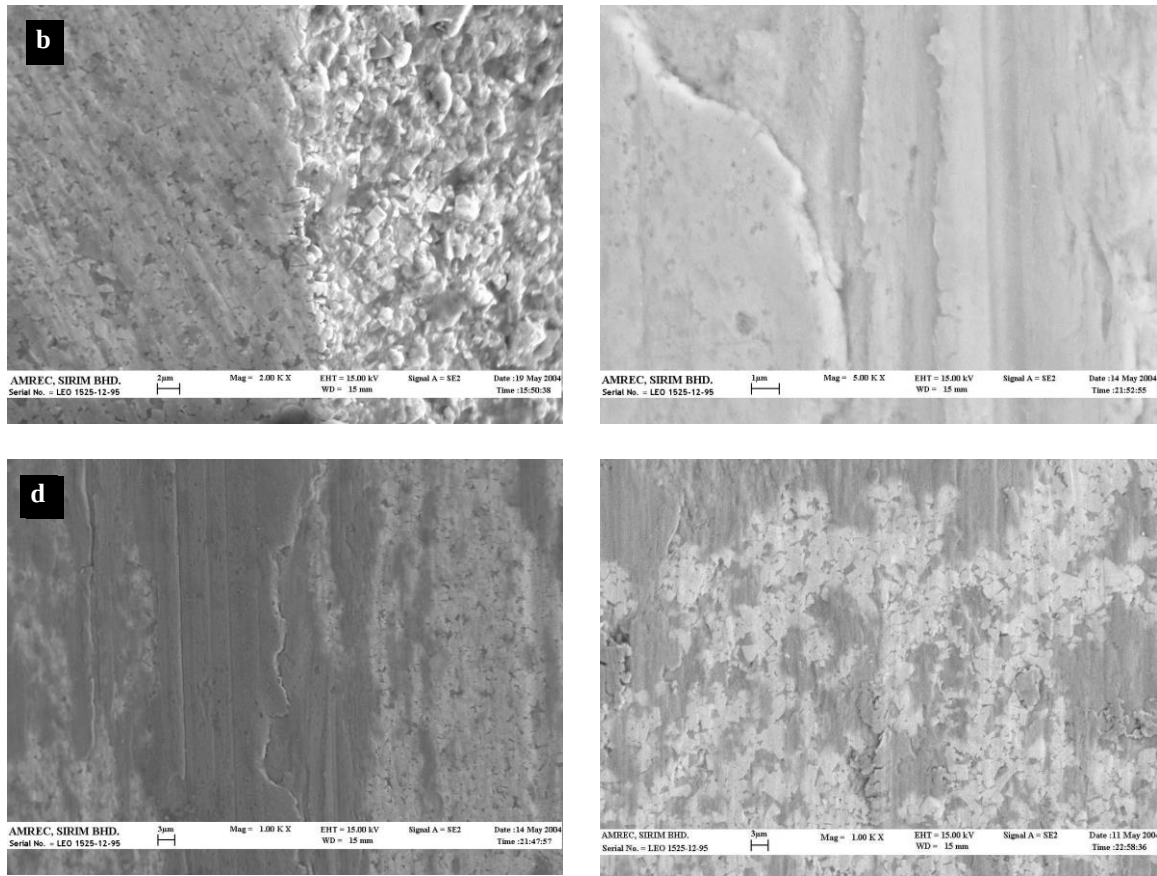
Figure 7a shows worn surface of the insert where the left side was the substrate surface after diamond coating has been disposed from and the right side was a diamond coating. When the substrate materials have been exposed, the harder peak asperities were ploughed into the wear surface (Figure 7b). This process is a manifestation of abrasion wear mechanisms. The abrasion mechanism was not observed on the subsequent turning and this phenomenon was taught to be due to blunting of the peak asperities during the turning processes. At the same, it was also observed that the material fragment from the work piece was transferred onto the insert surface and has started to form metallic junctions as well as to start growing. As turning process progressed, the transfer materials will be smeared and sheared on the worn surface of the insert (Figure 7c). The transferred films were continuously compacted, smeared and sheared on the sliding surfaces as the drilling progressed and finally formed a compound layer composed of tungsten carbide substrate material and element from work piece (Figure 7d). Energy Dispersive Analysis of X-Ray (EDAX) revealed that the transfer layers generated on the worn surface contain both materials from tungsten carbide substrate material and work piece. This process was due to process of mechanical alloying on transfer layers, a phenomenon observed by other researchers such as Chen & Rigney [7].

Figure 7: Surface morphology of substrate material. (a) wear surface (b) formation fragment material and abrasion mechanism, (c) transfer layer, (d) compound layer
